Inspection Report
Minerals Regulatory Program
Report Date November 23, 2005

Mine Name: DKG Quarry
Operator Name: Diamond K Gypsum

Permit number: M/015/041
Inspection Date: November 22, 2005
Time: 11:00 AM to 12:20 PM

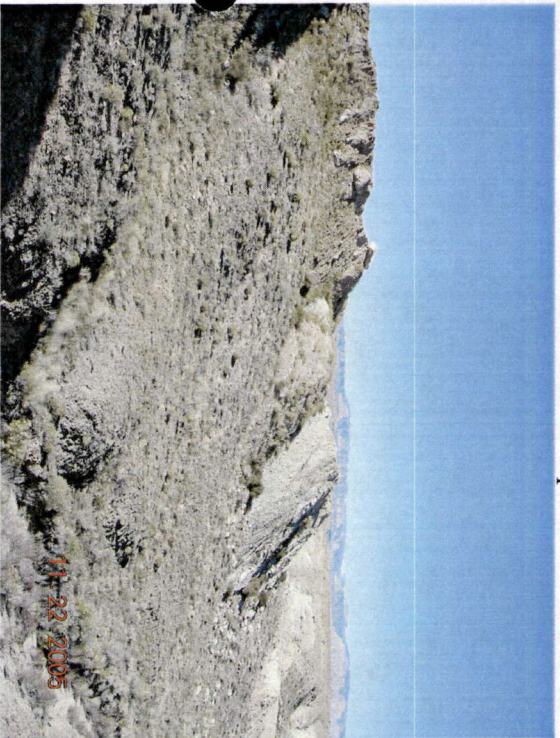
Photos 1 and 2 show a pile of waste material (mostly gypsum, it appears) that the operator will grade. This will mean disturbance of a slightly larger area.

Photo 1. The operator will try to knock down the pile of waste material in the center-right of this photo and cover it with soil.

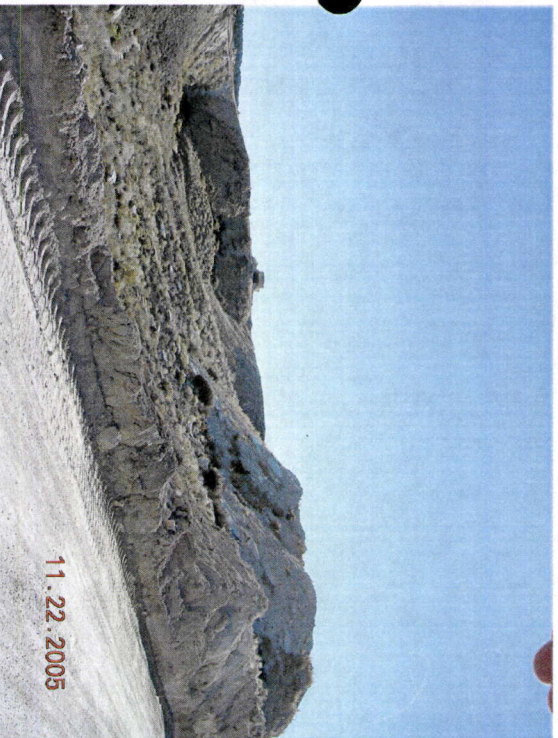
Photo 2. Another view of the waste material shown in Photo 1.

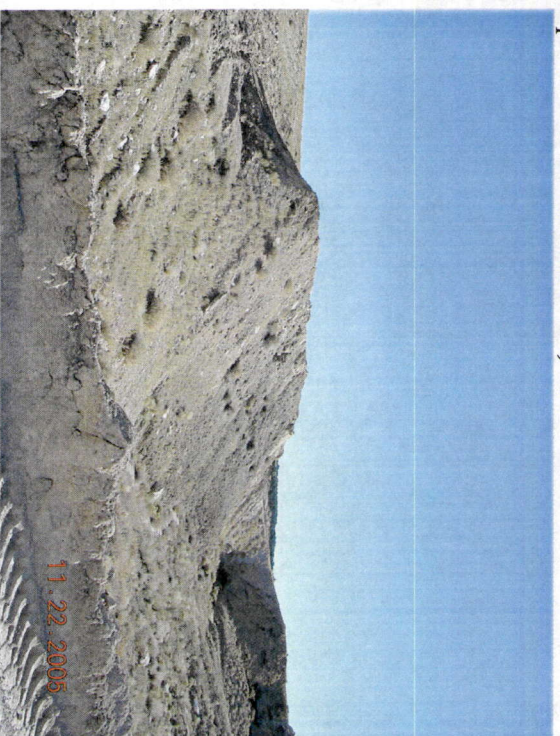
There is a natural drainage channel that begins about 100 yards above the area being reclaimed. This channel is blocked by the quarry, then there is a stretch that was not disturbed, then it is blocked again by the new road (Photo 3). This will create small impoundments when there is runoff, but this should not be a problem since the drainage area is small. It may enhance wildlife habitat since water is scarce in this area.

Photo 3. This mound is a rock outcrop that looks natural from this angle but not from the other side. This outcrop will be left.

The drainage near the center of this photo is blocked by the road in the foreground and also by the regraded mine. This drainage looks larger than it is; it only extends about 100 yards above the reclaimed area.

I asked the operator to slope the newly-regraded area so any runoff from this area would not flow into the drainage. Otherwise, it would increase the amount of water being ponded next to the road, and it might also create some erosion problems on the outslope of the quarry.

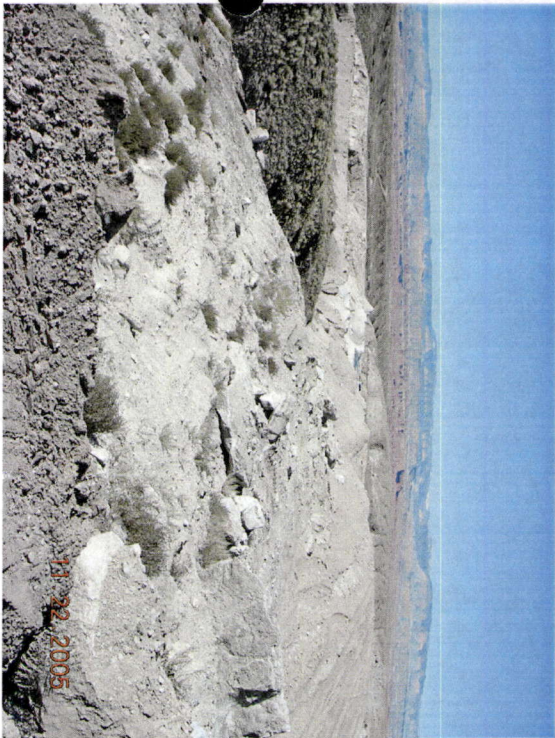
Photo 4. Gravel that the operator is going to try to spread over some of the reclaimed surface.

The soils in the area being reclaimed are fine textured and have very little rock, unlike the areas reclaimed in 2004. This concerns me because rocks tend to increase water infiltration and decrease runoff. There was an area with very gravelly soil on the southwest side of the area being reclaimed, and I suggested to Mr. Henry that, as far as possible, this could be spread over the top of the area being reclaimed.

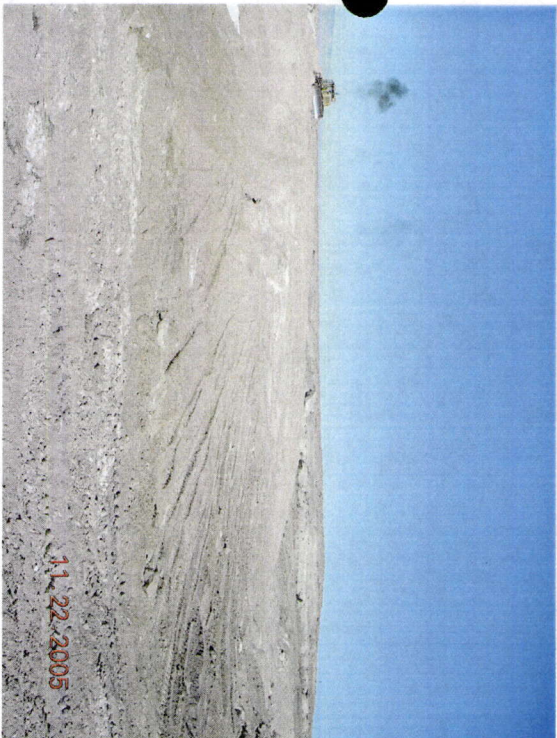
Photo 5. A portion of the reclaimed area. This still needs to be ripped and seeded.

Most of the area being graded still needed to be ripped. This needs to be done parallel to the contour. I am confident the operator well understands the concept of leaving the site rough.

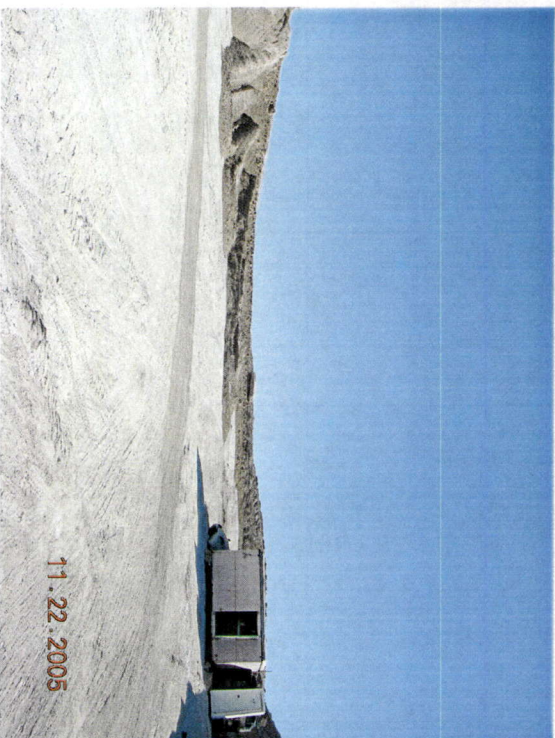
Photo 6 shows the boundary between the area being reclaimed and the active mine. The area being reclaimed is sloped so runoff from this area would go into the active mine which the operator does not want. The operator intends to build a berm across this boundary to divert runoff into a natural drainage channel.

Photo 6. This shows the boundary between the area being reclaimed and the active mine. Runoff from the reclaimed area would flow on to the active mine area, but the operator intends to build a berm to divert this water to a natural drainage.

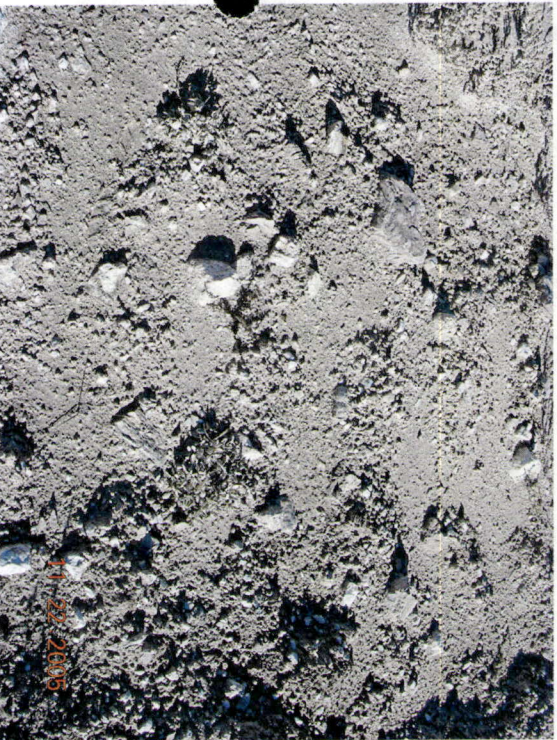
Vegetation in the area that was graded and seeded in 2004 is progressing well. This area is shown in Photos 8 and 9. There is a nice mixture of grasses and shrubs. I cannot yet identify the grasses, but they did not look like Indian ricegrass. Most of the shrubs appear to be Castle Valley clover and fourwing saltbush, but when the shrubs are this small, I have trouble distinguishing between shadscale and Castle Valley clover.

Photo 6. Vegetation in the area reclaimed in 2004.

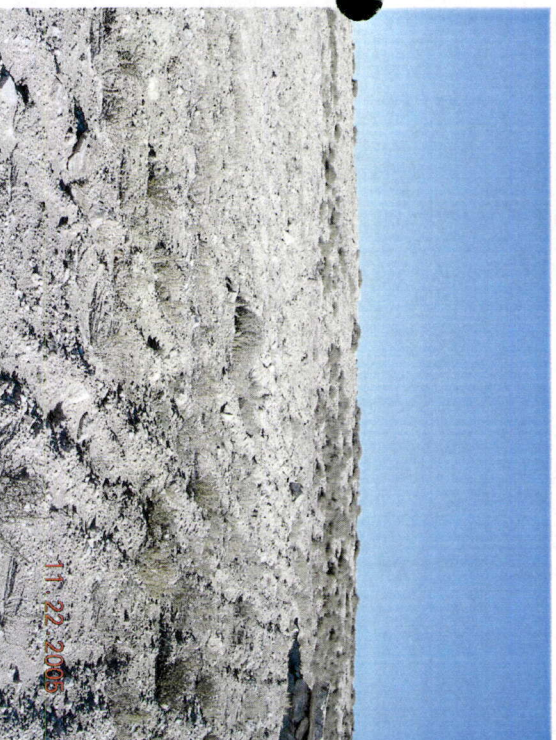
Photo 7. An overview of some of the area reclaimed in 2004.

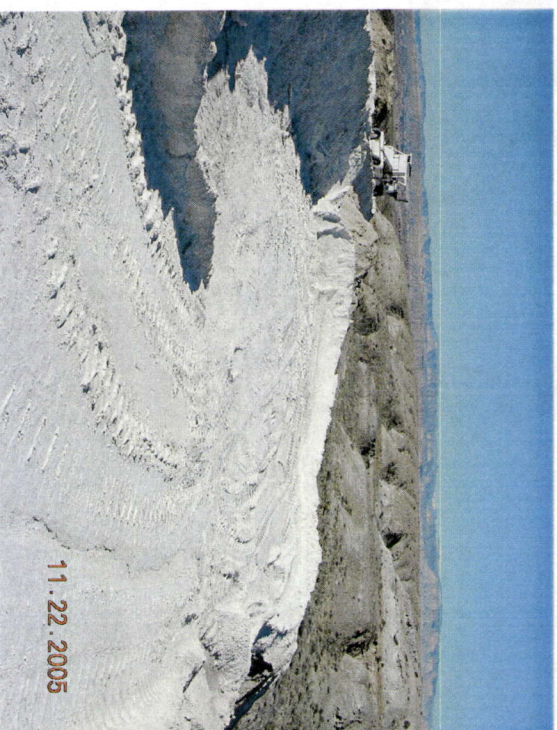
Photo 8. The operator intends to construct a small pond in this area to hold runoff from the upper part of the active mine.

I suggest that the operator install a notched silt fence to serve as the outlet for the upper catch basin. This would need to be keyed in to the embankment so it doesn't wash out.

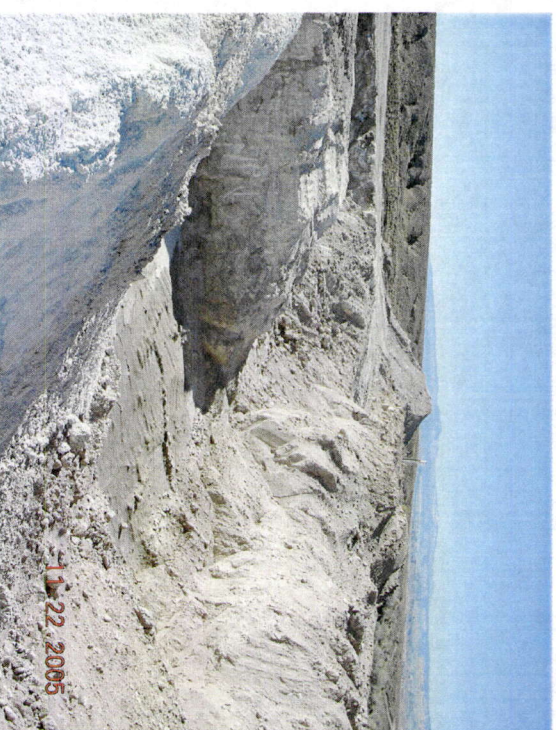
There is already a depression at the lower end of the quarry that serves as a catch basin (Photo 11), and this appears to be large enough that it has not caused problems.

Photo 9. A depression in the lower portion of the active mine.
